LAKE FRANKLIN PIERCE DAM
N.H. 00199

NHWRB-116.04

PHASE I INSPECTION REPORT
NATIONAL DAM INSPECTION PROGRAM

AUGUST 1978

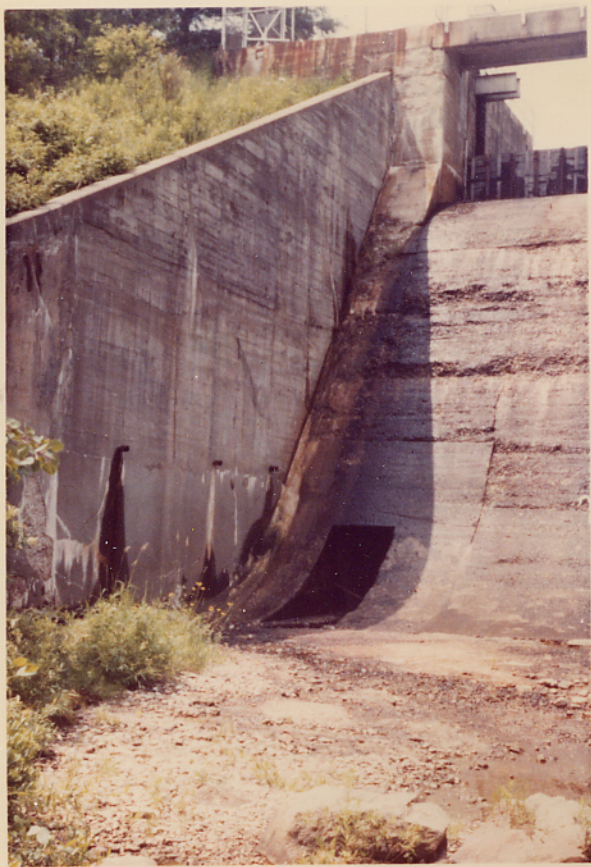
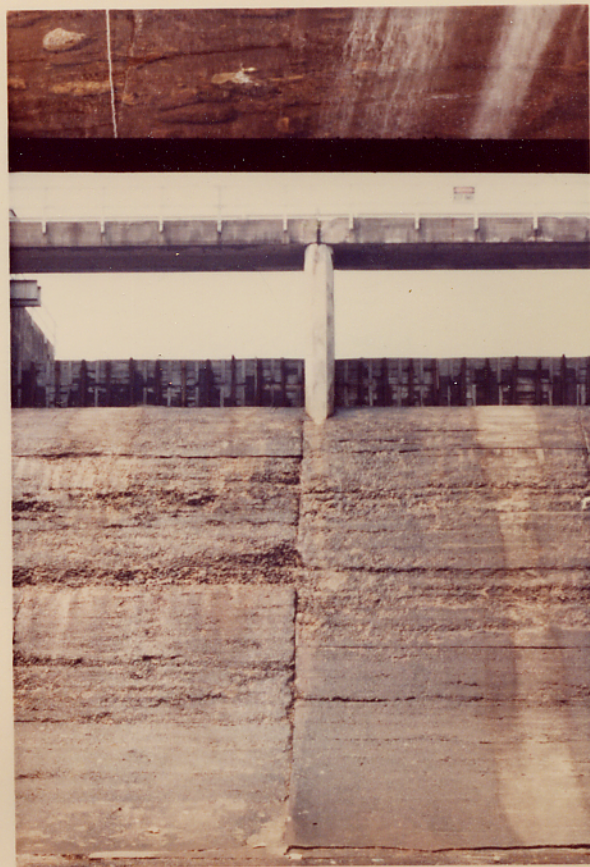
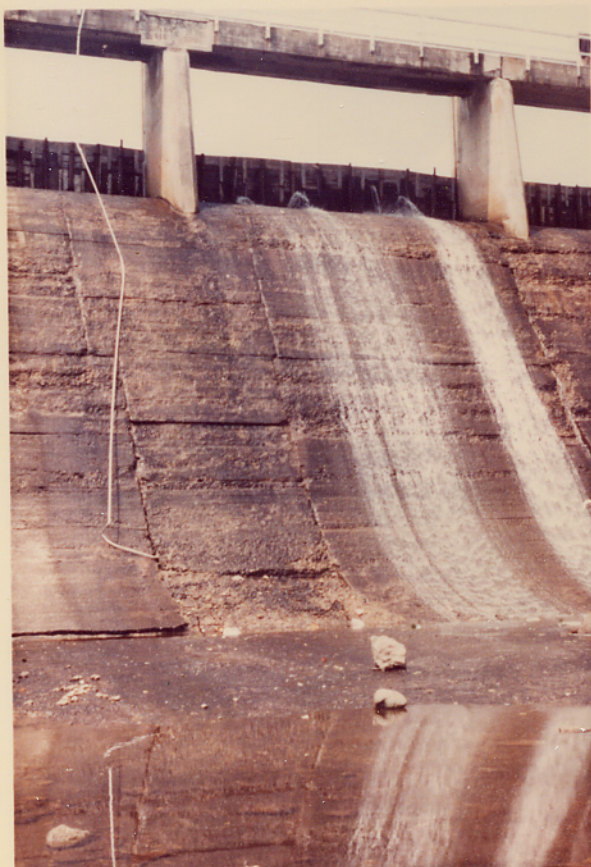
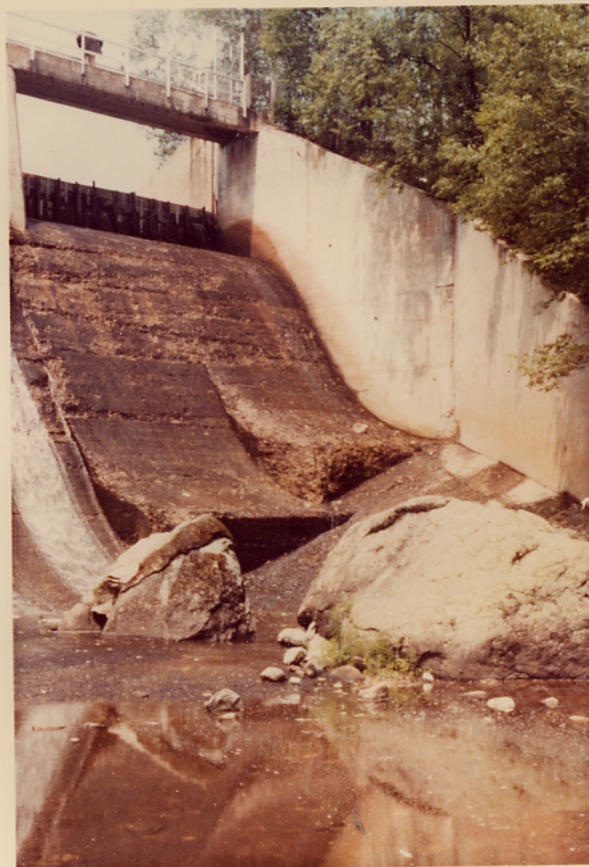
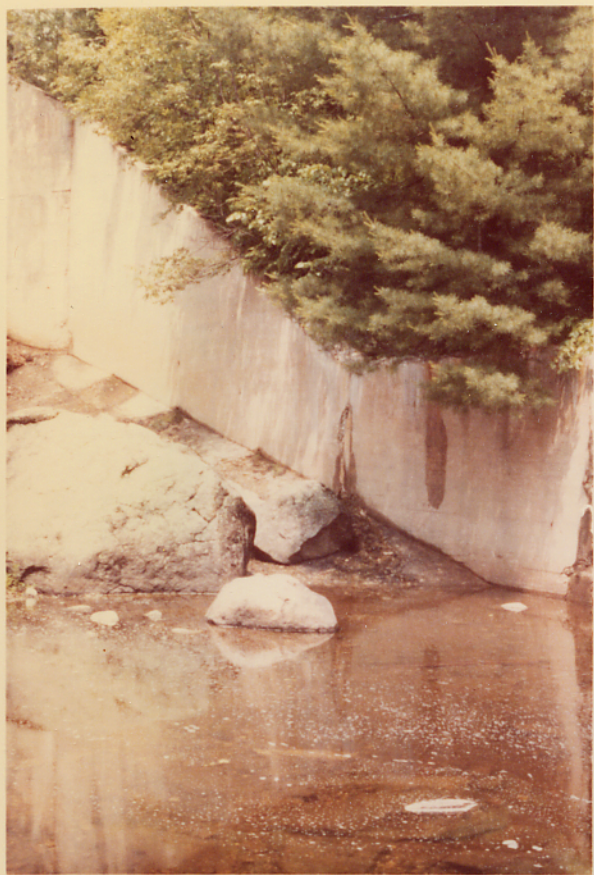
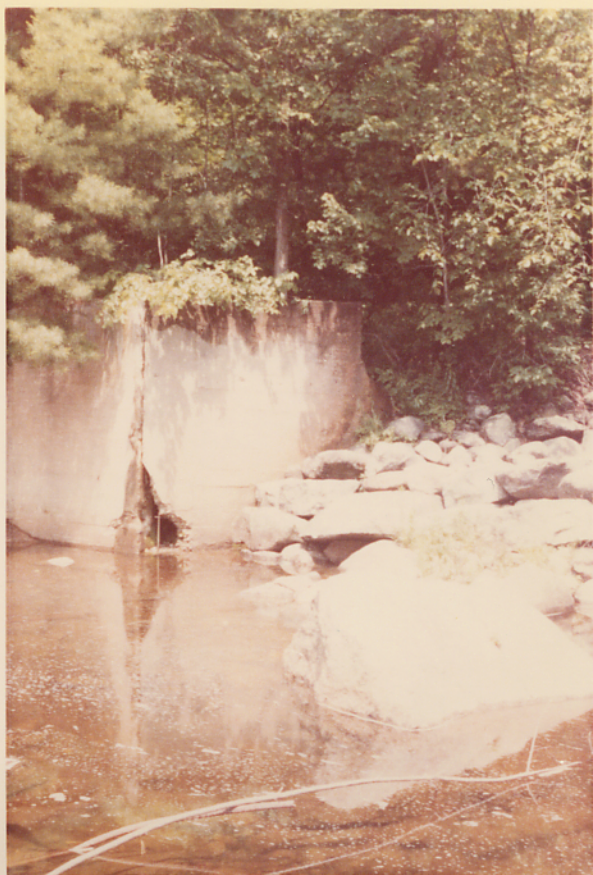
<u>Photo No.</u>	<u>Description</u>
1-6	Sequence of 6 photos taken clockwise from downstream of dam looking west toward downstream face of spillway showing south abutment; weepholes in wingwall, rectangular outlet for low level discharge at south end of spillway, spillway; weepholes in north abutment; downstream end of north abutment.
7	View from north end of spillway looking south toward south dike, showing trees on dike.
8	Looking west toward wet area downstream of south abutment of spillway. This area is more or less over the penstock and adjacent to the wingwall on south side of channel.
9	Seepage occurring at south side of penstock trench downstream of dam. May be groundwater discharging from adjacent high ground, may be from dam. Estimated rate - a few gallons per minute. No leakage from south (hill) side of trench further downstream.
10	Drain pipe that discharges adjacent to downstream end of north abutment. Pipe is rusted. Seepage coming out underneath pipe. Appears to be coming from roadway immediately above. Does not appear to be seepage from dam.

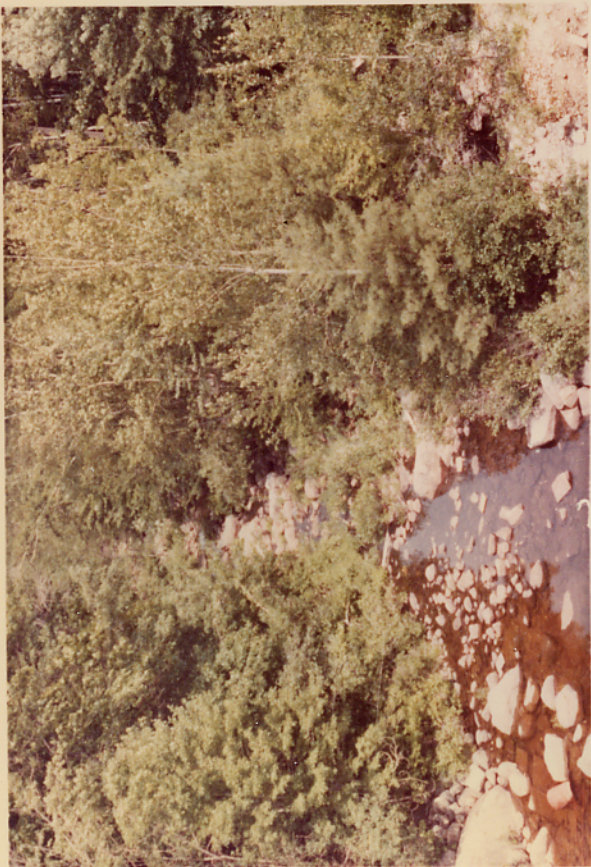
11	From service bridge looking toward channel downstream of spillway.
12	From north end of service bridge looking north along north dike showing bare soil on crest and trees and brush.
